#### Technical Report ARCCD-TR-02003

# 120-mm TARGET PRACTICE CONE STABILIZED DISCARDING SABOT WITH TRACER (TPCSDS-T) M865 (E3) REWORK REPORT (POP-RIVET DESIGN)

October 2002

### U.S. ARMY ARMAMENT RESEARCH, DEVELOPMENT AND ENGINEERING CENTER

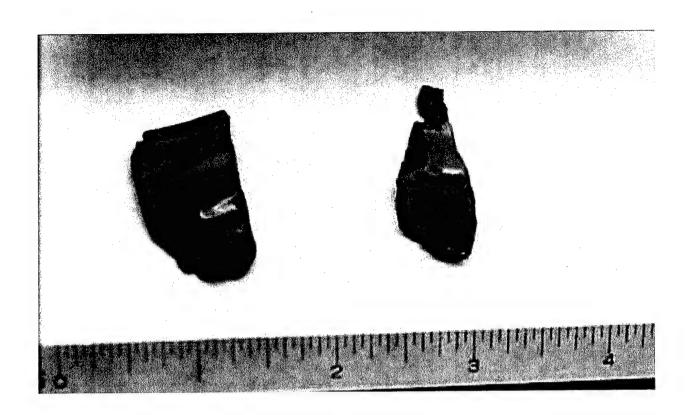
By May 2000, a modification consisting of a longer nylon insert and approximately 24 g of green epoxy was introduced to provide a more durable projectile to cartridge case attachment. Initial field experience with the modified rounds in October 2000, indicated that the joint strength issue was resolved, but there had been a number of instances of chambering failures due to large pieces of adapter bonded to green epoxy (fig. 1) adhering to an epoxy paint coating in the forward area of the cannon chamber, called chamberage. The residue issue was serious enough to warrant establishing a team to investigate the problem. By June 2001, a modification consisting of half the amount of epoxy (approximately 12 g of green epoxy) was introduced to still provide a durable projectile to cartridge case attachment, which also eliminated the residue in the gun tube issue. After a thorough investigation by the team, a report was issued titled "Report of Barrel Residue Investigation Team," dated January 25, 2002.

Figure 1
Green epoxy residue with adapter material attached

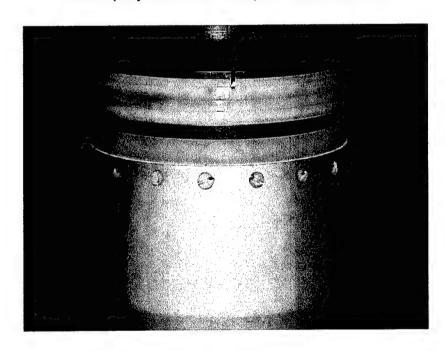
Figure 2
Eighteen setscrew design

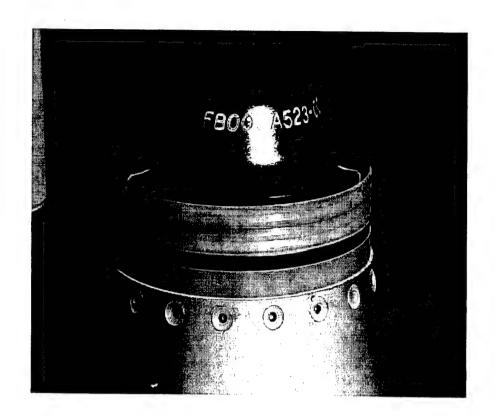
Figure 3
Eighteen pop-rivet design

This design reinforced the existing joint by inserting a series of nylon pop rivets through the case adapter/insert cover interface equally spacing each fastener around the cartridge circumference (fig. 4). This required the drilling and countersinking of the case adapter and insert cover interface (fig.6) to a controlled depth then installing modified pop rivets. The design required a drill fixture to consistently position the holes in their exact location (fig. 7). The modification to the pop rivet (figs. 8 and 9) consisted of machining the head to allow for countersinking and a below flush installation. The modification to the pop rivet was less costly when compared to the tapping operation of countersunk screw design.

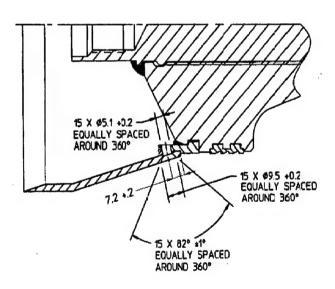
Figure 5
Case adapter and insert cover interface with setscrews

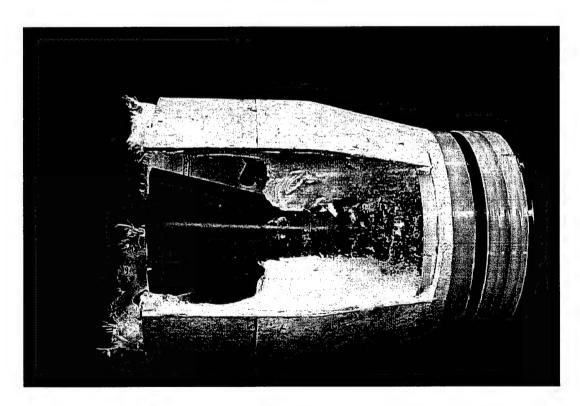
Figure 10 Foam fill design

This design was initiated by ATK and pursued by ARDEC requiring the drilling of a hole in the case adapter and injecting urethane foam into the ullage area between the case adapter and slotted conical fin to stabilize the projectile. The design provided the projectile with additional support in fin area (fig. 10). This design seemed to provide a solution to the problem, but encountered large negative delta pressures, which could not be resolved (fig. 11). To insure the negative delta pressures were inherent of the foam fill design, 36 rounds were modified to test the foam fix concept.

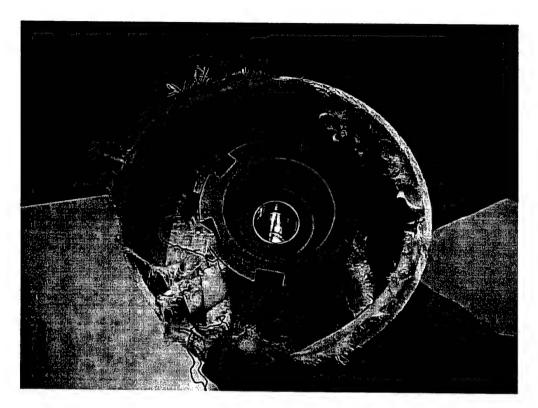
Figure 11 Foam fill design (rear view)

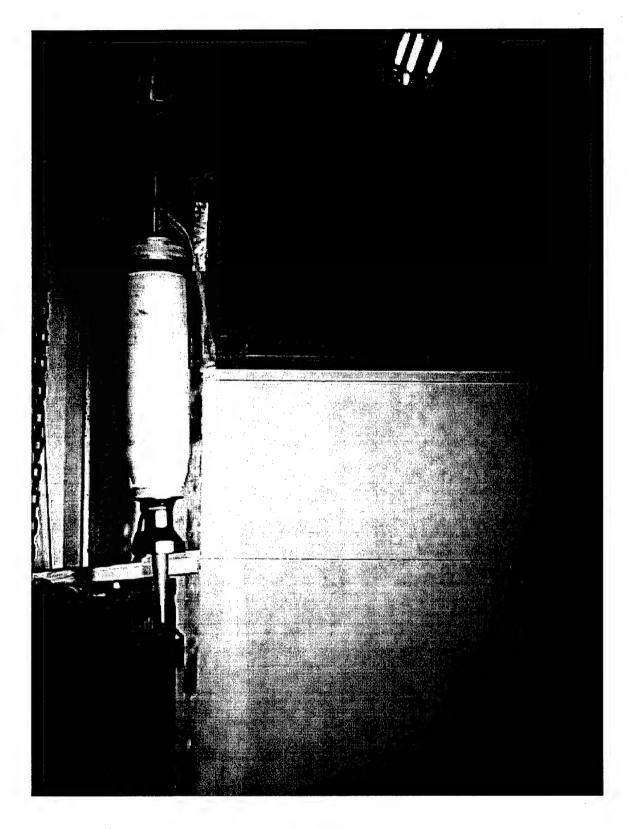
The pendulum test (fig. 13) was developed early on during the field fix rework program to provide a good initial screen for a design's level of robustness and anticipated performance during the user-loading test. The pendulum test is intended to simulate a side impact of the cartridge with an object and places a dynamic bending load on the projectile/adapter interface (fig. 14). This test depicts a worst-case scenario of what can happen to a cartridge when being handled within the turret of the tank.

Figure 13 Pendulum test

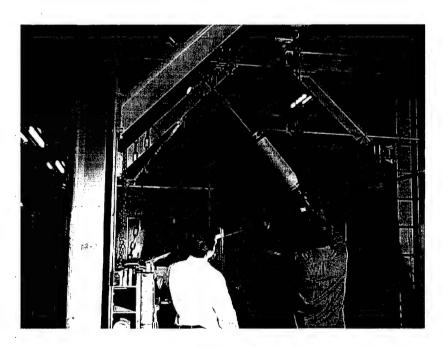
Figure 15 Pendulum test setup

The pendulum test provides a controllable side impact to the front of a projectile simulating dropping the front of the round on the breechblock during chambering or otherwise hitting the projectile during unpackaged handling. The pendulum test impact point is 3.75 in. from the tip of the core (fig. 15) and the distance from the pivot point to the tip of the core is 77 in. (fig. 15). The cartridge is suspended upside down by the case base then pulled back and released to impact a steel angle iron on a wall (fig. 16). The distance of the swing is measured diagonally from the wall intended impact to the core intended impact. The test consists of a series of swings starting at 2 ft then going to 3 ft, 4 ft, etc. (fig. 16). The test is stopped when the joint separates (fig. 17) to a point where it does not look like it chambers or the sabots become loose. The test is never conducted beyond 6 ft. The design that came apart in the field had only taken 3 ft to separate the case adapter from the insert cover not allowing the projectile to chamber.

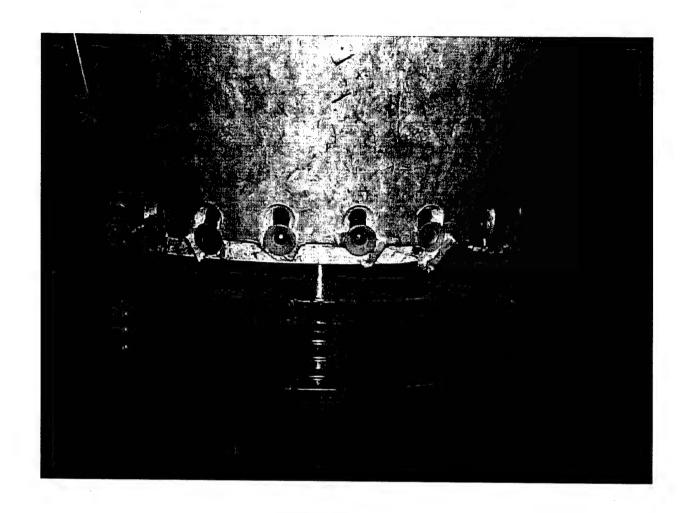
Figure 17 Pendulum test failure
